Manildra Solar Farm Construction – Environmental Representative (ER) Inspection Report

Date of Inspection	10 August 2017	Location of Inspection	Manildra Solar Farm
ER	Demelza Scott	Proponent Representative	Bjorn Schultz
Weather	Fine and sunny	Construction Contractor Representative	Jeff Drummond Baz Tuppin
Inspection Summary	Improvement Opportunity – 0 Corrective Action – 3		
Comments / Observations	<p>The site was in its third week of pre-construction activities at the time of the inspection. Temporary site buildings had been placed on site until the construction site compound is completed. The internal main access road was under construction and earthworks were underway for the construction site compound.</p> <p>The site was tidy at the time of the inspection. Erosion and sediment controls for stockpiles and earthworks were implemented and managing erosion and sediment risk well.</p> <p>A number of controls were awaiting implementation including erection of speed signage, waste receptacles and development of registers including complaints, incidents and waste.</p> <p>The site presented a low environmental risk at the time of the inspection.</p>

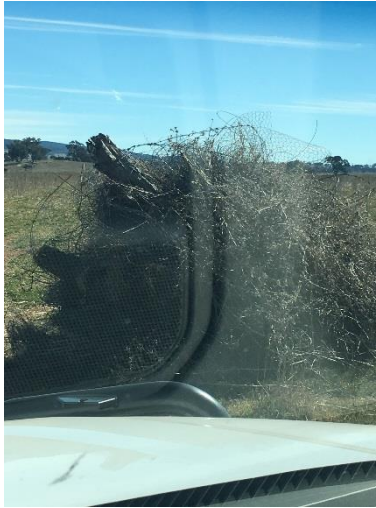
Issue	Observations & Corrective Actions	Due Date	Photographic Record
Waste	Minimal waste has been generated at site to date. General solid waste from crib room is taken to Manildra Waste Facility twice weekly.		
	Waste receptacles for segregation of construction waste have not been set up on site. Sighted Contractor's Weekly Environmental Site Inspection Checklist that included an improvement opportunity to order waste bins and have them in place prior to commencement of the construction program.		
	Spoil and topsoil observed to be stockpiled separately.		
	Old farm fencing has been removed from the majority of the development envelope. Temporary stockpiles of timber fence posts and wire are located across the site.

Old fencing to be transported to MWF for recycling.		
	No greenwaste has been generated to date.

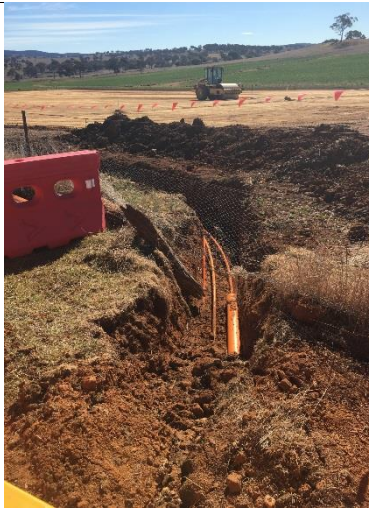
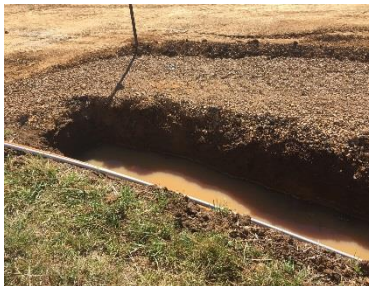
Issue	Observations & Corrective Actions	Due Date	Photographic Record
Flora and Fauna	<p>A trench under the main access road for services and effluent reuse has been open for two days. Protocol 4: Trenching from the Flora and Fauna Management Plan (FFMP) had not been implemented.</p> <p>Water truck operating on the adjacent main access road had filled the trench with water.</p> <p>Corrective Action 170810 - 02: Manage trenches in accordance with Protocol 4: Trenching to minimise trap hazard for fauna.</p>	<p>Advised at time of audit to correct immediately.</p> <p>17/08/2017</p>

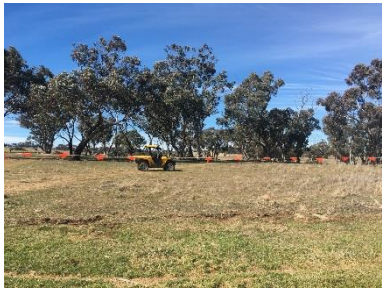
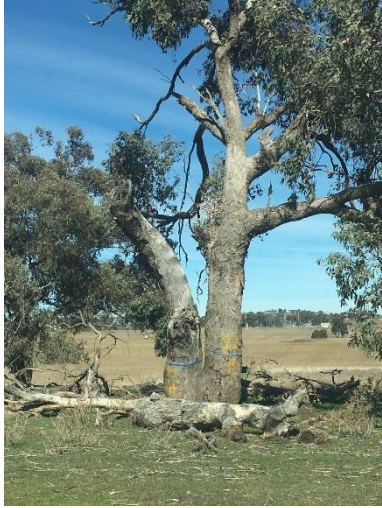
Issue	Observations & Corrective Actions	Due Date	Photographic Record
	<p>Ecologist (Geolyse) on site at time of ER inspection conducting pre-clearing surveys and identification of trees to be retained and those to be removed. Stands of remnant vegetation to be retained have been flagged as 'no go zones'.</p> <p>Clearing to be conducted no earlier than 21 August.</p>

Ecologist (Geolyse) to conduct weed mapping. This is yet to be completed.

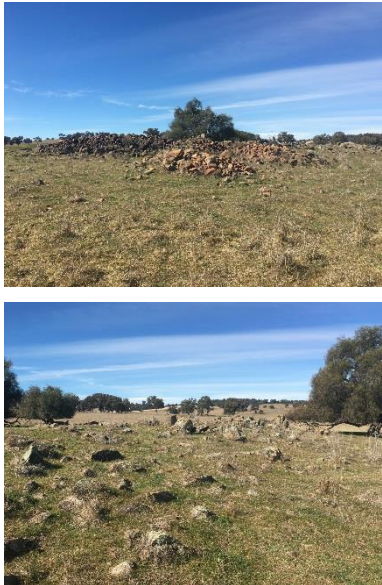
Issue	Observations & Corrective Actions	Due Date	Photographic Record
	No rocky outcrops have been required to be cleared for the pre-construction activities, as per the predictions in the Pre-Construction Activities Plan.

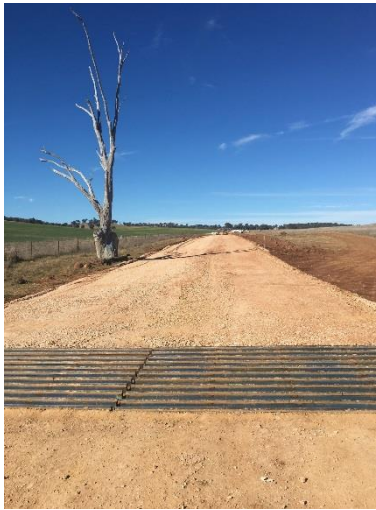
Issue	Observations & Corrective Actions	Due Date	Photographic Record
Traffic	<p>Main access road and site compound were under construction at the time of the inspection.</p> <p>A grader, roller and water truck were operating. Trucks were delivering road construction materials at the time of ER inspection.</p>

Traffic control is via UHF Channel 10 including pedestrian movements.		
	Designated parking areas were separated from construction traffic movements.		
	Advised that site speed limit is 20 km/hr. No speed limit signage has been erected at site. Sighted Weekly Site Inspection Checklist that identified this as an Improvement Opportunity. Speed limit signage has been ordered and will be erected prior to commencement of the construction program.		
Heritage	Cultural heritage awareness including the presence of the stone ruin are included in induction material.

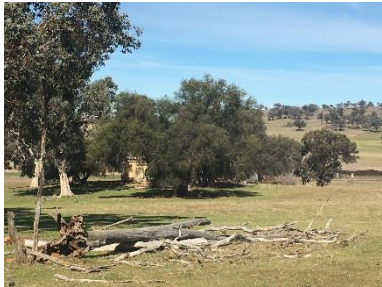
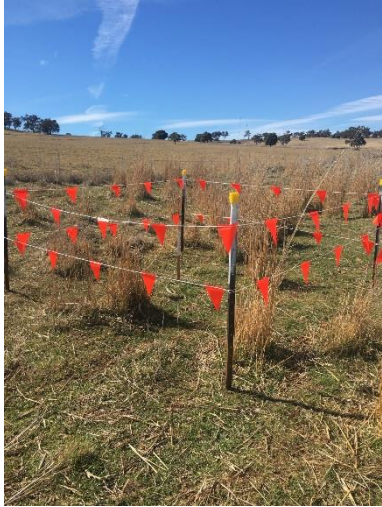
Issue	Observations & Corrective Actions	Due Date	Photographic Record
	<p>Sites of potential Aboriginal scatter and stone ruin were identified on site by flagging and signage.</p> <p>Archaeologist (NSW Archaeology) confirmed that the scatter is of low significance and does not require any specific management protocols. RCR have committed to protecting the scatter and on completion of perimeter fencing, it will be outside of the construction footprint.</p>

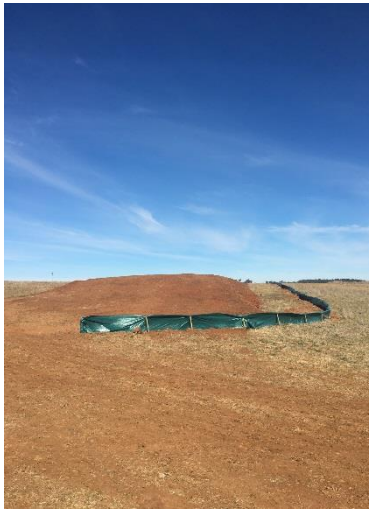
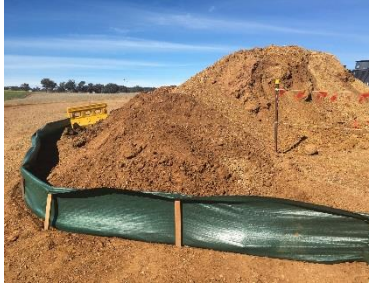
Issue	Observations & Corrective Actions	Due Date	Photographic Record
Soil and Water	Two stockpiles were constructed at the time of ER inspection. Aerated Wastewater Treatment System (AWTS) was in the process of being installed. Temporary stockpile of spoil was protected by a sediment fence on the downslope side. Topsoil stockpile was located behind the temporary site compounds and car park. It was protected by a sediment fence on the downslope side.

Weekly site inspections are being conducted that include erosion and sediment controls. Sighted records of completed inspections conducted by SCECO.

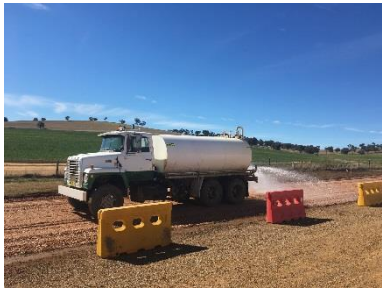
Issue	Observations & Corrective Actions	Due Date	Photographic Record
	<p>Water cart operating for construction of main access road.</p> <p>Road construction methodology involves completing small sections of road at a time to minimise areas of disturbance and reduce dust generation.</p>

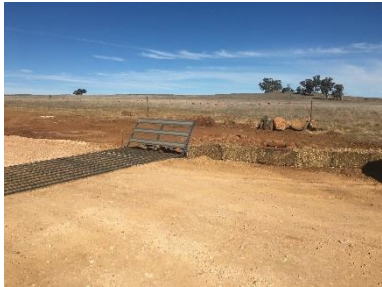
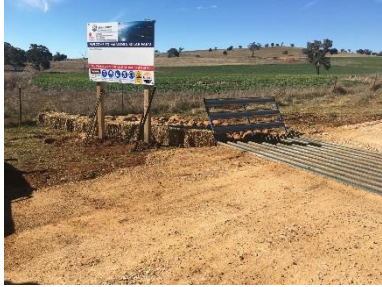
<p>Stabilised entry consisted of a rumble grid, hay bales reinforced with large rocks.</p>

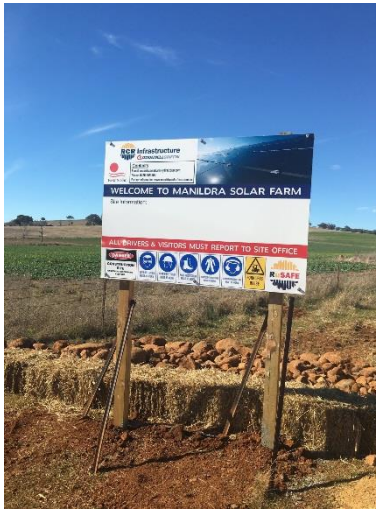
Issue	Observations & Corrective Actions	Due Date	Photographic Record
	Site has received some wet weather since pre-construction works commenced (30 mm over 3 days). The site has not received 20 mm in 24 hrs to trigger wet weather inspections and additional erosion and sediment controls.		
	While the construction site compound is being developed, site amenities are port-a-loos. SCECO advised that these are double skinned to provide protection against spills of raw sewage.		
Community Consultation	Community information day was held prior to commencement of construction. Details provided to community e.g. construction start dates to be reviewed at next ER inspection.		
Complaints	<p>Contact information is displayed on the sign at the entrance to the construction site.</p> <p>Manildra Solar Farm website has been updated with complaints contact details.</p> <p>No complaints have been received to date. A complaints register is yet to be established.</p>
