Manildra Solar Farm Construction – Environmental Representative (ER) Inspection Report

Date of Inspection	11/10/2017	Location of Inspection	Manildra Solar Farm
ER	Demelza Scott	Proponent Representative	Bjorn Schultz
Weather	Fine and sunny	Construction Contractor Representative	Baz Tuppin Andrew Conning
Follow up from previous inspection	Corrective Actions: CA 130917 – 01: Conduct appropriate checks and inductions on subcontractors, their staff and plant/equipment prior to conducting any work on the project.		
Inspection Summary	Improvement Opportunity - 2 Corrective Action - 1 Open Corrective Actions: CA 130917 – 01: Conduct appropriate checks and inductions on subcontractors, their staff and plant/equipment prior to conducting any work on the project. CA 111017 – 01: Fence rocky outcrops within the development envelope that are not to be disturbed including a 2.5m buffer as per FFMP or provide justification for not fencing. Appendix A Corrective Action Register to track identification and close out of corrective actions.

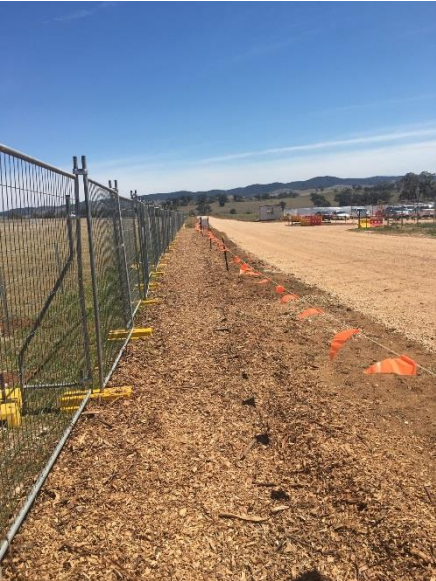
Issue	Observations & Corrective Actions	Due Date	Photographic Record
Site Compound	<p>Site access control has been set up since the last inspection and contractors were on site constructing the BAR on Packham Drive.</p> <p>The sides of the main access road have been formed and seeded as part of progressive rehabilitation.</p> <p>The main access road appears to be in good condition and handling the movement of heavy vehicles for delivery of plant and materials to site.</p>

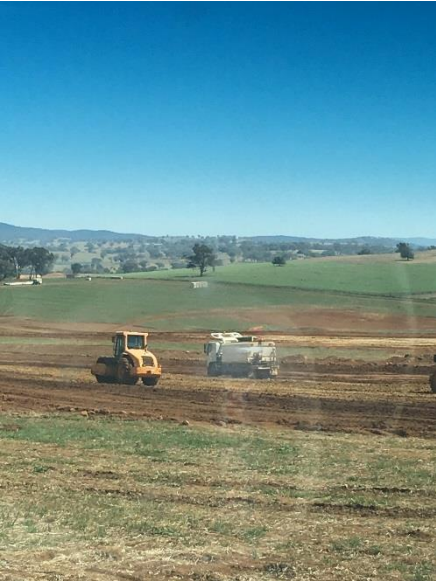
Issue	Observations & Corrective Actions	Due Date	Photographic Record
Dust	<p>At the time of the inspection, two water trucks were operating on site to manage dust for the works on Packham Drive and the earthworks on Arrays 7 and 8. There was minimal dust being generated as part of the works.</p> <p>Heavy vehicles were observed to be using designated temporary tracks.</p> <p>There were no deliveries to site during the site inspection.</p>

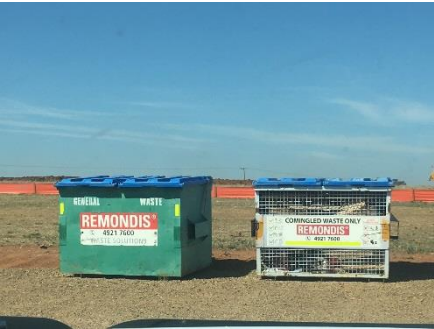
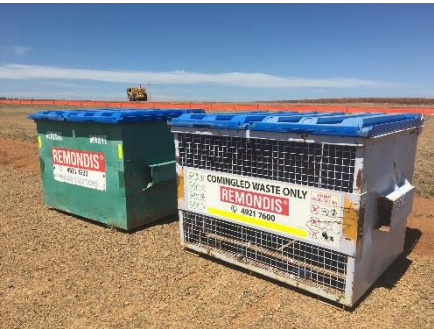
Issue	Observations & Corrective Actions	Due Date	Photographic Record
Waste	<p>Waste and recycling bins were observed on site and waste was observed to be segregated. RCR have not received a waste docket for the first removal yet. RCR have not inducted the waste collection driver and he attended site on the day of the inspection and did another waste collection.</p> <p>Refer to CA 130917.</p>

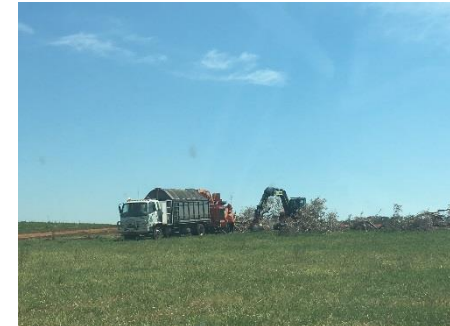
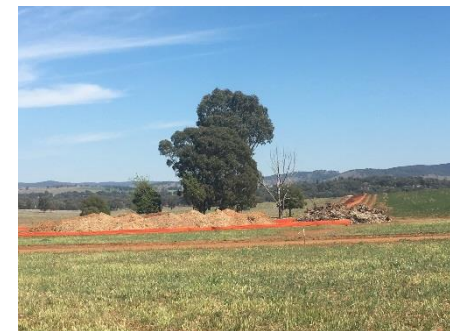
All trees to be cleared as part of the project have been felled and Geolyse have provided a draft Post Clearing Report. Protocol 7: Hollow Bearing Tree Removal appears to have been followed. Trees identified for removal were marked, pre-clearing survey was conducted by a qualified ecologist, the ecologist was present during tree felling and conducted a post clearing inspection and report. The post clearance report did not make reference to the placement of nestboxes as per the FFMP. This is to be reviewed at the next ER Inspection.

Tree trunks have been taken offsite for firewood for the local aged care units as per an agreement with the landholder. Stumps have been ground and a contractor is operating on site to chip other vegetative material. Mulch has been used in the pedestrian walkway and will be used for the mulch berm.

To date, rocky outcrops have been left insitu where they are not in the vicinity of trees to be removed. The FFMP Protocol 2 requires that rocky outcrops within the development envelope are fenced with a 2.5m buffer, wherever possible. This was not observed to be occurring on site.

Where rocky outcrops were in the vicinity of trees to be removed and posed a risk to personnel, individual rocks were moved to an area immediately adjacent to their original location. This is consistent with the FFMP Protocol 6.

AWTS irrigation area is showing some signs of growth with irrigation of treated effluent from site facilities.

FFMP states that, where security considerations permit, perimeter fencing will not contain barbed wire, particularly the top strands. Perimeter fencing was observed to be constructed with three top strands of barbed wire.

Corrective Action 111017 – 01: Fence rocky outcrops within the development envelope that are not to be disturbed including a 2.5m buffer as per FFMP or provide justification for not fencing.

Improvement Opportunity 111017 – 02: RCR to provide copy of Australian Standard for Power Station Security and correspondence from First Solar that requires the top strand barbed wire in perimeter fencing.

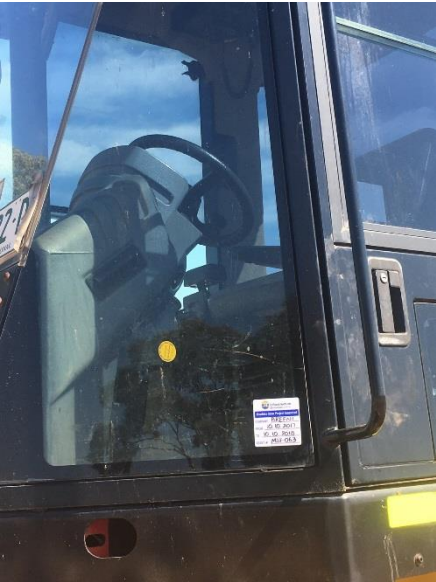
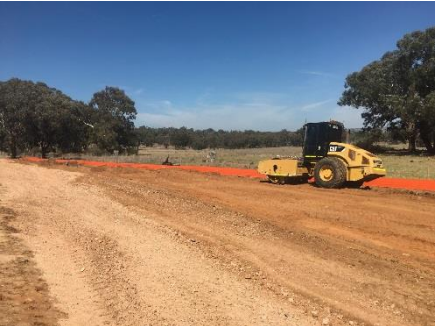
Issue	Observations & Corrective Actions	Due Date	Photographic Record
Traffic	<p>Plant and vehicle drivers were observed to be actively using the UHF network to communicate traffic movements around site.</p> <p>Sighted Council Works Permit for activity on a public road (Packham Drive BAR construction) and RCR plant acceptance documentation for Pad Foot Roller that was working on Packham Drive.</p>

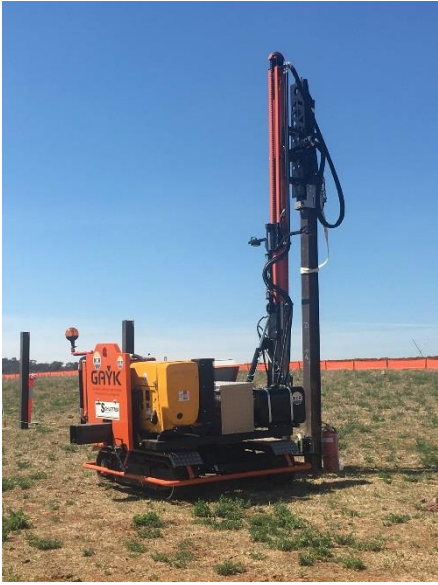
Issue	Observations & Corrective Actions	Due Date	Photographic Record
Noise	<p>RCR have been conducting test pile driving in an area adjacent to the site compound to determine noise levels and test mitigation measures. Once this activity commences it will constitute 'High Noise Activity'.</p> <p>RCR have not applied for Out of Hours Work approval yet.</p>

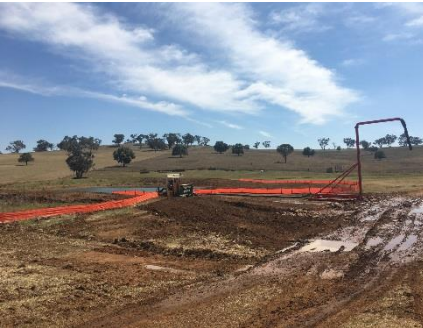
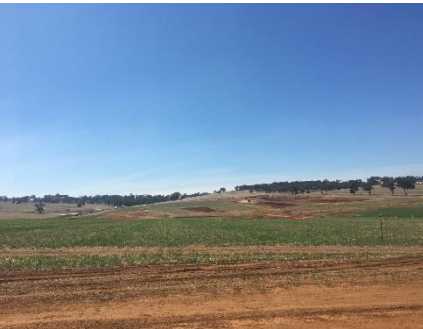
Issue	Observations & Corrective Actions	Due Date	Photographic Record
Soil and Water	<p>RCR have cleaned out the former farm dam, and formed and seeded the batters. The dam receives water from catchment runoff and a supply from the landholder. Sediment fencing has been installed upslope and downslope of the dam as an erosion and sediment control measure and encourage access at the designated point. A pump and standpipe have been commissioned this week for filling site water trucks. RCR had laid rock at the fill point however it has not been sufficient to prevent muddying of the access way. RCR have identified this as an issue in their Weekly Environmental Inspection and plan to lay additional rock to stabilise the area.</p> <p>The site received 16mm in 36hrs over the weekend. Although this did not trigger a wet weather inspection as per the CEMP, RCR conducted a Wet Weather Inspection to check the effectiveness of erosion and sediment controls.</p>
