Manildra Solar Farm Construction – Environmental Representative (ER) Inspection Report

Date of Inspection	14 March 2018	Location of Inspection	Manildra Solar Farm
ER	Demelza Scott	Proponent Representative	Nil
Weather	Warm, sunny, moderate wind	Construction Contractor Representative	Don Martin
Inspection Summary	Improvement Opportunity – 0 Corrective Actions – 3 Open Corrective Actions: CA191217 – 02: Develop and implement a program for the installation of nest boxes in accordance with the FFMP. CA210218-02: Implement all practicable dust mitigation measures to cease emission of visible dust generated by the project. CA210218-03: Place additional rock to stabilise the internal road on the north-east perimeter from water flowing onto site. CA210218-04: On completion of construction, remove the access road from the array to the farm dam so as not to impede natural water flow.		
Comments / Observations	The earthworks contractor has finished on site. Drilling and pile driving of posts for the solar arrays was ongoing. Trenching is ongoing for cable installation. External fencing was being erected along the northern perimeter. Arrays and electrical installation is occurring across the s

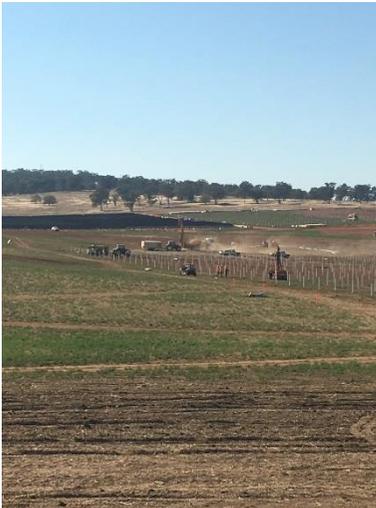
Issue	Observations & Corrective Actions	Due Date	Photographic Record
<i>Dust</i>	<p>Localised generation of dust associated with vehicle movements on site roads and drill rig operation was observed.</p> <p>One water truck was operating on site during the inspection. Two water trucks were previously operating on site. The addition of a second truck would allow for wetting down of earthworks activities as well as the internal road network to further reduce dust generation.</p>

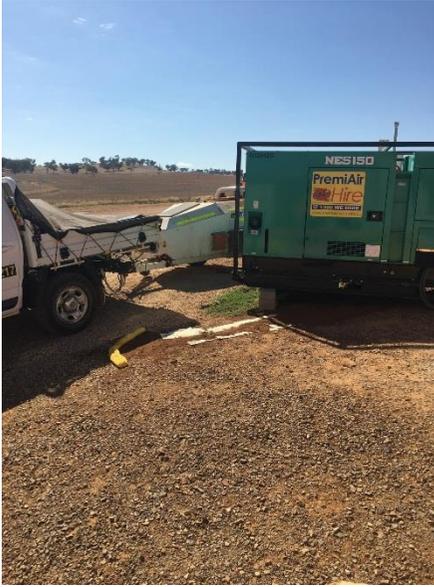
Issue	Observations & Corrective Actions	Due Date	Photographic Record
<i>Chemicals and Fuels</i>	<p>A small oil spill occurred at the onsite refuelling station / generator for the site offices on Monday 12 March.</p> <p>The spill was absorbed using the spill kit maintained at the refuelling station. An incident report was not available for review at the time of the ER Inspection. This is to be reviewed at the next ER Inspection in April.</p>

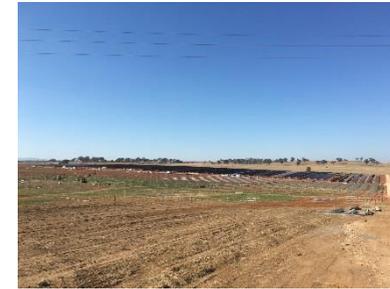
RCR advised that nest boxes are due to arrive on site the week of 19 March.
Trenching is almost complete.
Good regrowth was observed across the site.

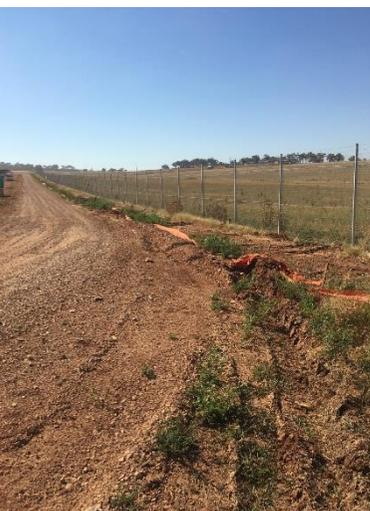
Issue	Observations & Corrective Actions	Due Date	Photographic Record
Soil and Water	<p>RCR provided photos and a site plan for the installation of rock check dams across the site prior to the ER Inspection.</p> <p>Additional hay bales have been purchased for the site to be placed behind rock check dams and to be used within the main drainage line to break up the slope length. RCR advised that these will be installed by the end of the week (16/03/2018).</p> <p>Once array installation is complete, hay will be spread in high risk areas to provide temporary groundcover. Identified areas include between the northern road and arrays 6, 7 and 8, along the north-south road and around arrays 3, 4 and 5.</p> <p>Rill erosion was still evident on the batter approaching the O&M building. RCR advised that they are currently seeking quotes from contractors to remediate the batter and stabilise it to prevent future erosion.</p> <p>A section of the sediment fence in the south-west corner of the site was observed to be down and required maintenance to ensure protection from offsite movement of sediment.</p> <p>Corrective Action 140318-03 – Conduct maintenance on sediment controls to ensure ongoing effectiveness.</p>	30/03/2018
