Manildra Solar Farm Construction – Environmental Representative (ER) Inspection Report

Date of Inspection	23/05/2018	Location of Inspection	Manildra Solar Farm
ER	Demelza Scott	Proponent Representative	Bjorn Schultz
Weather	Fine and Sunny	Construction Contractor Representative	Danny Dyson and Natalija Baban
Inspection Summary	Improvement Opportunity – 2 Corrective Actions – 3 Open Corrective Actions: CA210218 – 03: Place additional rock to stabilise the internal road on the north-east perimeter from water flowing onto site. CA210218 – 04: On completion of construction, remove the access road from the array to the farm dam so as not to impede natural water flow. CA110418-01: Implement stricter quality control on mulching of cardboard including smaller sizing, removal of plastic, nails and staples. CA110418-03: Conduct maintenance on sediment fences across the site, particularly on the south-western boundary. CA230518-01: Manage wind-blown litter on site and on neighbouring properties including covering the mulch stockpiles with netting. CA230518-02: Install temporary sediment controls along the southern boundary that can be moved and reinstated as works are conducted in the area. C

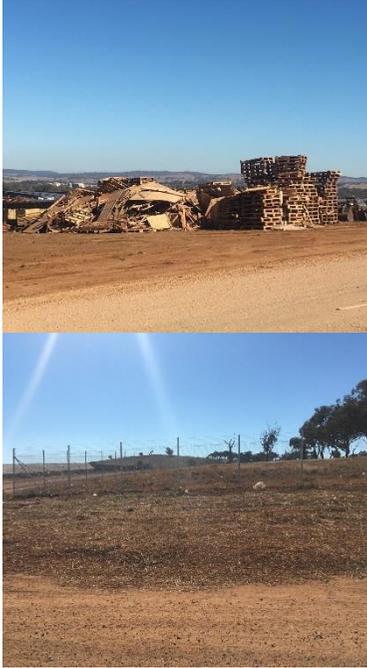
Issue	Observations & Corrective Actions	Due Date	Photographic Record
Waste	<p>Wind-blown litter from the mulched cardboard and pallets was an issue on site and on the neighbour's property. Waste packaging was also observed scattered across site, yet to be picked up.</p> <p>First Solar and RCR advised that mulched cardboard and pallets will not be used in a mulch berm as previously discussed. Discussions are underway for the mulched material to be taken to Molong waste management facility where it will be mixed with general household waste to aid in compaction of waste. First Solar and RCR are in discussions with VISY regarding accepting the module boxes for recycling.</p> <p><i>Corrective Action 230518-01: RCR to manage wind-blown litter on site and on neighbouring properties including covering the mulch stockpiles with netting.</i></p>

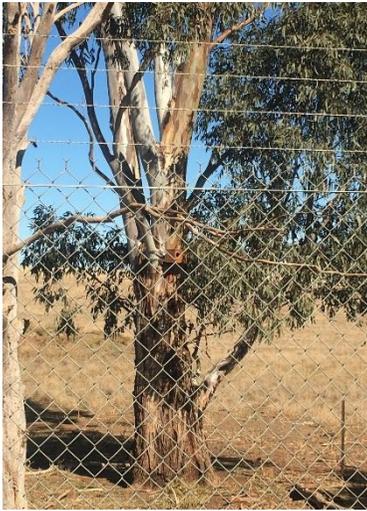
Issue	Observations & Corrective Actions	Due Date	Photographic Record
Flora and Fauna	<p>Nest box installation was well underway, with 50 out of the 60 proposed nest boxes installed. The remaining 10 were planned to be installed later in the week. A map is to be created showing the location of nest boxes.</p> <p>First Solar is still reviewing the proposal from RCR to amend the proposed screen planting plan to allow for roadside planting. First Solar have requested that the consultant who prepared the original visual impact assessment review the revised plan for consistency with the EA and Project Approval.</p> <p>Weeds are appearing to establish themselves across site. RCR advised that they are waiting until the majority of personnel have demobilised from site before commencing weed spraying.</p> <p><i>Improvement Opportunity 230518-02: RCR to commence weed spraying for listed priority weeds once personnel numbers have reduced on site.</i></p>

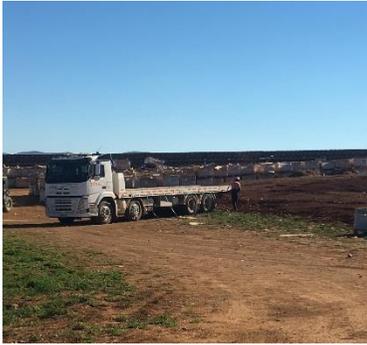
Traffic	<p>As the site is being demobilised, there has been an increase in heavy vehicle movements in removing demountable infrastructure such as crib rooms, construction sheds etc.</p>

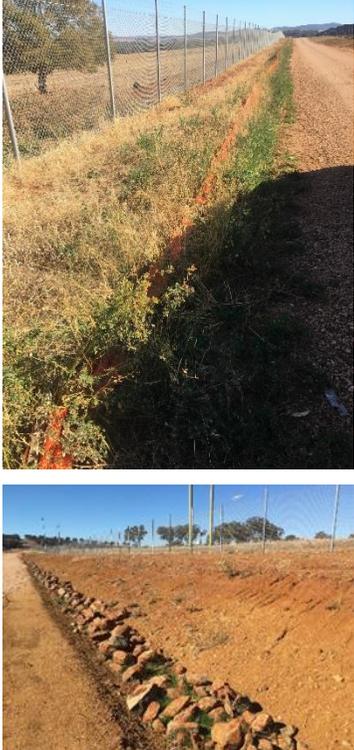
Issue	Observations & Corrective Actions	Due Date	Photographic Record
Soil and Water	<p>Sediment fences along the south-western boundary were dilapidated and are in need of maintenance. RCR were reluctant to reinstate the sediment fences as there is still work to be done in that area including additional gravel top up on the road and planting screening trees along the boundary fence, which would further damage the sediment fences. RCR have advised they would be inclined to install temporary controls such as straw bales in place of sediment fences following works.</p> <p>Good progress in regeneration was observed with noticeable seed strike in areas spread with topsoil and seeded. RCR have been in discussion with a local agronomist who advised that rain is forecast in July and seeding should be scheduled for then. RCR advised that 25% of the site is yet to be seeded. Some areas showed signs of compaction and will require ripping in preparation for seeding.</p> <p>The batter in the south-western part of the site near the operations and management buildings was reported as eroding a number of months ago with rill erosion evident and no regrowth on this batter. RCR advised that the contractor is to reshape the batter, spread topsoil, secure jute matting and seed. However the drawing provided by RCR did not provide sufficient information to confirm that this had been agreed with the contractor.</p> <p>Corrective Action 230518-02: RCR to install temporary sediment controls along the southern boundary that can be moved and reinstated as works are conducted in the area.</p> <p>Corrective Action 230518-03: RCR to confirm that the contractor will reshape the batter, spread topsoil and seed as well as secure jute matting or equivalent.</p>	08/06/2018

Reference	Action	Category A: Stop Work B: Immediate Action C: Closed within 2 weeks D: Non-critical	Date Opened	Responsibility	Date Closed
230518-03	Confirm that the contractor will reshape the batter, spread topsoil and seed as well as secure jute matting or equivalent.	C	23/05/2018	RCR SCECO
