Manildra Solar Farm Construction – Environmental Representative (ER) Inspection Report

Date of Inspection	14/11/2017	Location of Inspection	Manildra Solar Farm
ER	Demelza Scott Maurice Pignatelli	Proponent Representative	Nil
Weather	Fine, partly cloudy	Construction Contractor Representative	Baz Tuppin John Sharman
Follow up from previous inspection	CA 111017-01 is no longer applicable as all rocky outcrops are to be removed for the installation of the solar arrays. IO 111017-01 remains outstanding. Refer to waste. CA 130917-01 remains outstanding. Refer to chemicals and fuels.		
Inspection Summary	Improvement Opportunity - 0 Corrective Action - 0 Open Corrective Actions: CA 130917 – 01: Conduct appropriate checks and inductions on subcontractors, their staff and plant/equipment prior to conducting any work on the project. Appendix A Corrective Action Register to track identification and close out of corrective actions.		
Comments / Observations	Pile driving of posts for the solar arrays has commenced on Array 7 and 8, earthworks have extended across the site and gravel was being delivered and more permanent access roads formed across the site. Erosion and sediment controls were in

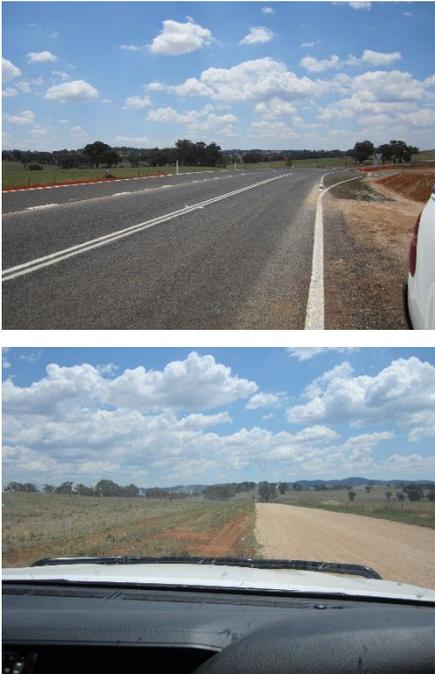
Issue	Observations & Corrective Actions	Due Date	Photographic Record
<i>Site Compound</i>	<p>BAR on Packham Drive has been completed.</p> <p>Site access control now includes boom gate.</p> <p>Sides of the main access road were showing good growth following seeding.</p>

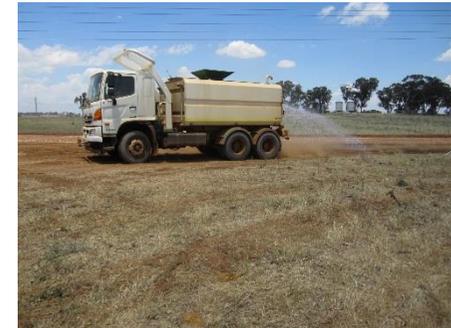
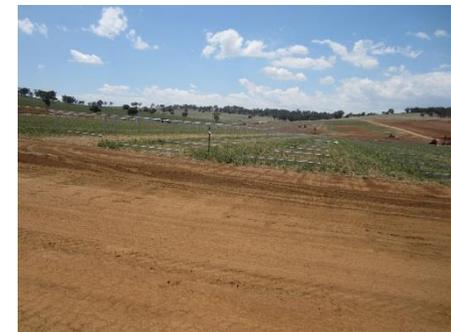
Three water trucks were operating at the time of inspection to manage dust for the earthworks across the site.

Disturbed areas of the site are being seeded within seven days of handover from the earthworks contractor, and watered to achieve groundcover targets.

Deliveries of gravel for the access roads across the site were occurring during the inspection. Loads were not contributing to dust generation.

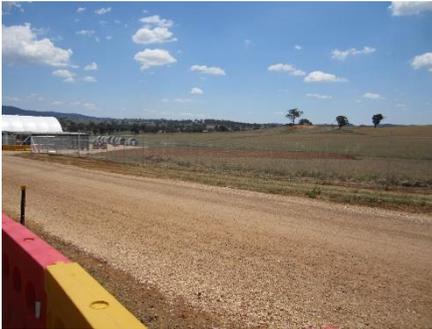
Issue	Observations & Corrective Actions	Due Date	Photographic Record
Flora and Fauna	<p>RCR advised that no rocky outcrops will remain in situ therefore CA111017 is no longer applicable. Rocky outcrops were observed to be removed in the vicinity of earthworks with rocks stockpiled.</p> <p>Topsoil stockpile has been relocated from site adjacent to main site compound, to AWTS irrigation area.</p> <p>RCR advised that nest boxes to replace hollows from trees removed on the project are still under construction.</p>
