Manildra Solar Farm Construction – Environmental Representative (ER) Inspection Report

Date of Inspection	18/04/2018	Location of Inspection	Manildra Solar Farm
ER	Demelza Scott Maurice Pignatelli	Proponent Representative	Bjorn Schultz
Weather	Fine and sunny	Construction Contractor Representative	Don Martin
Inspection Summary	Improvement Opportunity – 1 Corrective Actions – 2. Open Corrective Actions are: CA191217-02: Develop and implement a program for the installation of nest boxes in accordance with the FFMP CA210218-01: Repeat construction noise monitoring at the residences of receptor 2 and receptor 5 to confirm whether noise generated by the project is below the Assessment Criteria and Work Generating High Noise Impact Levels. CA210218-03: Place additional rock to stabilise the internal road on the north-east perimeter from water flowing onto site. CA210218-04: On completion of construction, remove the access road from the array to the farm dam so as not to impede natural water flow.

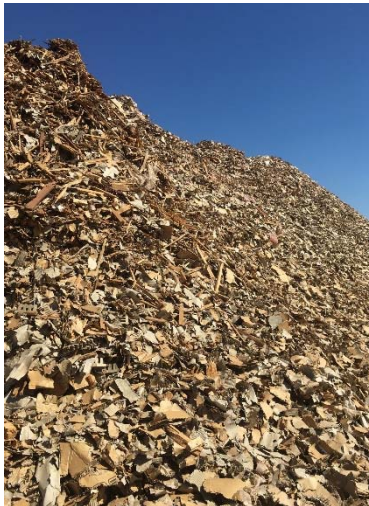
Issue	Observations & Corrective Actions	Due Date	Photographic Record
Dust	<p>RCR advised that dust hasn't been an issue despite the dry conditions. Bulk earthworks are complete and with the demobilisation of the earthmoving contractors the traffic movements around site have reduced.</p> <p>Some dust was observed during the site inspection associated with vehicle movements and drilling/pile driving. This dust was localised in nature and not causing any harm or nuisance to neighbouring properties.</p>		
Waste	<p>RCR advised that the mulching contractor is to be mobilised three times to progressively mulch the cardboard and NEXTracker waste. RCR advised that negotiations with Cabonne Council to take the NEXTracker waste are ongoing. RCR are proposing to use the mulched cardboard to construct a mulch berm on the south-western boundary in accordance with the Soil and Water Management Plan (SWMP). RCR advised that it would be covered with jute matting to prevent windblown rubbish onto neighbouring properties.</p> <p>The mulch stockpiles were inspected. As previously reported, First Solar had stipulated specifications for mulched material including removal of nails and other extraneous materials and sizing of the final mulched product. The mulch pieces were observed to be very large and there were significant amounts of plastic wrap and other extraneous materials in the final product. The ER is concerned that the use of this mulched product to construct a mulch berm would result in an ongoing source of litter from the development as the jute matting breaks down.</p> <p>On review of the SWMP, there is no timing specified for construction of the mulch berm. Given that the SWMP states that the mulch berm was intended to prevent sediment movement offsite, it should have been installed prior to commencement of bulk earthworks and would provide little additional protection if installed on completion of construction.</p> <p>Corrective Action 110418-01 – Implement stricter quality control on mulching of cardboard including smaller sizing, removal of plastic, nails and staples.</p>	4/05/2018
