## Manildra Solar Farm Construction – Environmental Representative (ER) Inspection Report

Date of Inspection	14/06/2018	Location of Inspection	Manildra Solar Farm
ER	Demelza Scott	Proponent Representative	Bjorn Schultz
Weather	Fine and sunny	Construction Contractor Representative	Glenn Tilley
Inspection Summary	<p>Improvement Opportunities – 0      Corrective Actions – 2</p> <p>CA140618-01    Remove all litter from site and offsite before handover from RCR to First Solar.</p> <p>CA140618-02    Reinstate sediment fencing along southern boundary of MSF prior to handover from RCR to First Solar.</p> <p>Outstanding corrective actions are summarised in Appendix A.</p>		
Comments / Observations	<p>A number of contractors were on site at the time of the audit:</p> <ul style="list-style-type: none"><li>• Moving the power line alignment around the solar arrays</li><li>• Mulching cardboard and pallets</li><li>• Loading and transporting mulched material off site</li><li>• Electrical connection of remaining solar arrays.</li></ul> <p>The site is well into demobilisation with the site entry, storage facilities in the site compound and a number of the site buildings removed. RCR advised that th

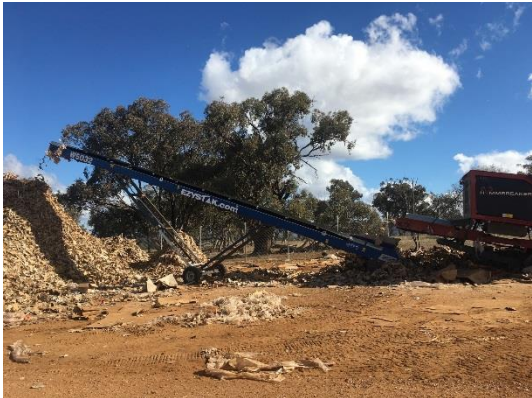
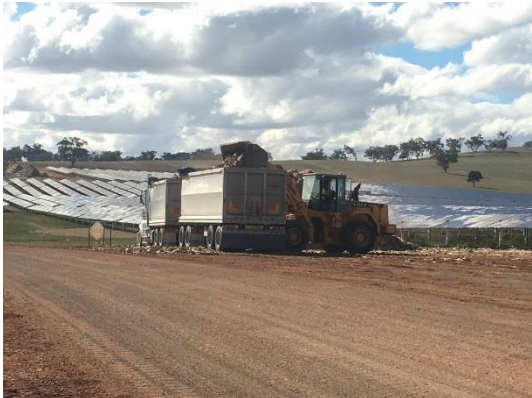
Issue	Observations & Corrective Actions	Due Date	Photographic Record
<b>Waste</b>	<p>Wind-blown litter from the mulched cardboard and pallets continued to be an issue on site and on the neighbour's property. RCR advised that the majority of litter was generated during loading of the mulched material onto trucks for transport to the Molong waste management facility. RCR advised that staff have been conducting daily pickups of plastic waste from the neighbour's property and across site.</p> <p>The mulching contractor and the waste transport contractor were on site at the time of the inspection (refer photos). One truck was observed leaving the site and the load was covered. RCR advised that all mulched material will be removed from site prior to the next inspection.</p> <p><b>Corrective Action 140618-01: Remove all litter from site and offsite before handover from RCR to First Solar.</b></p>

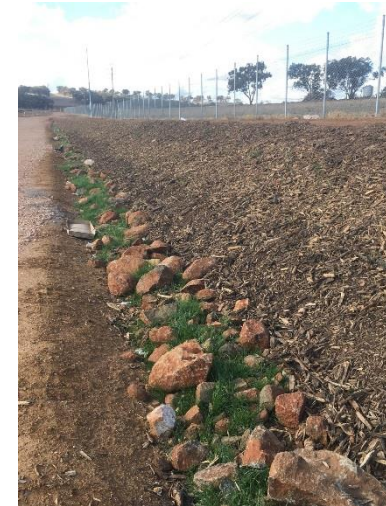
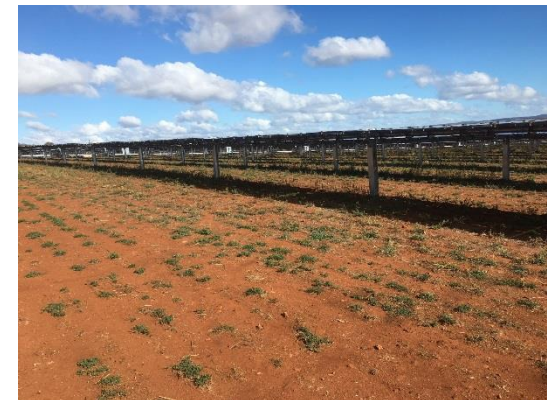
The sediment fence along the southern boundary is still dilapidated and no temporary erosion and sediment controls have been installed.

Rehabilitation of the batter along the southern boundary of the site, near the O&M building has been completed including jute mesh, mulching, tree planting, rock protection and drip irrigation. An additional batter is currently undergoing rehabilitation by the same contractor.

Germination across the site is very patchy as shown in the photos. Areas that weren't disturbed have a good cover of Lucerne, areas that were mulched with straw or woodchip show good signs of germination, weeds are establishing in some areas, some areas are yet to be seeded. RCR are still developing a plan for seeding the remaining areas of the site.

***Corrective Action 140618-02: Reinstate sediment fencing along southern boundary of MSF prior to handover from RCR to First Solar.***
